## Stage 2 - Server Cabinets in Final Position

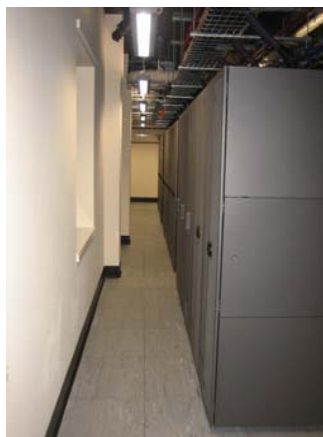
Rear Access to Server Cabinets

Each cabinet has been strategically placed to maximise the amount of room around the cabinets for efficient air flow and maintenance access.

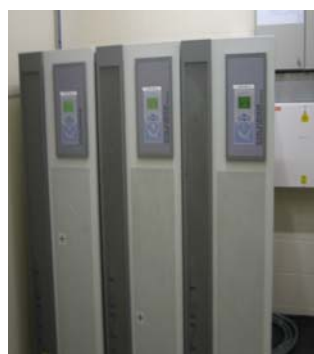
New UPS Room

The new UPS room has been completed with 3 UPS units working together. Each unit shares the load ensuring adequate power redundancy for the Servers.

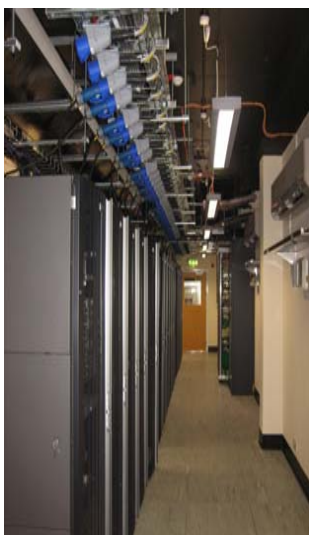
All 17 Server Cabinets in Position

The Server Room now has all the cabinets situated in their final positions.

Total of 17 Server Cabinets are available, 8 of these are already filled with existing Servers.

The remainder are ready waiting, with appropriate services, for future Server application installations.
